SAFETY ALERT

AUSTRALIAN STEEL INSTITUTE
SAFETY GROUP

Number:	SA0018
Subject:	Operator struck by coil
Date:	October 2006

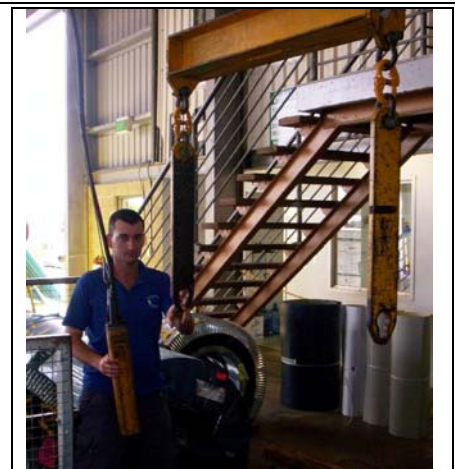
- Casual employee was operating overhead crane, under direct supervision, to load coils onto the decoiler using the approved lifting frame.
- Casual employee incorrectly positioned himself between the coil being moved and the row of bulk coil on the floor behind him. The supervisor did not detect this positioning.
- The casual employee then, inadvertently, selected the West button on the pendant control instead of East. The coil travelled towards him and as he realized this he released the control button.
- The swing of the coil caused him to be pinned between the moving coil and the row of bulk coil behind him.
- Casual employee suffered abdominal bruising.

- Reinforce the need to:
 1. Stop and review area for hazards before moving a load.
 2. Not put yourself 'in the line of fire'.
 3. Move the load safely, as low as practicable, and keep away from people.
- Include skill assessment under control conditions in employee induction prior to being authorised to use equipment.

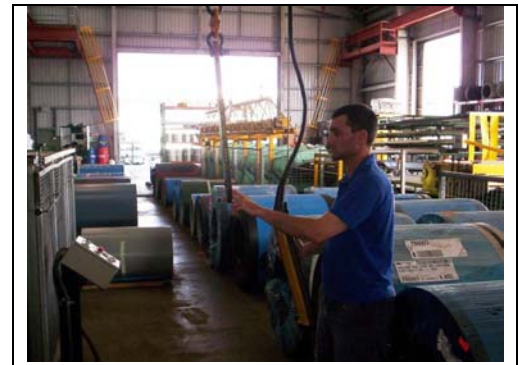
- Casual employee was experienced in overhead crane operation but not at this workplace and he was not licensed.
- He had not oriented himself with the directional compass of the overhead crane and admitted that he pushed the wrong button.
