DESIGN MERIT

The iconic West Gate Bridge is one of Australia's most important links in the national transportation network. Officially opened in 1978, the 2.6km bridge now carries 160,000 vehicles each day, including 24,000 trucks and heavy vehicles.

The West Gate Bridge includes a highly unique and complex 850m long cable stayed steel box girder central portion over the Yarra River and segmental prestressed concrete box girder approach viaducts of 670m and 870m long on the western and eastern sides respectively.

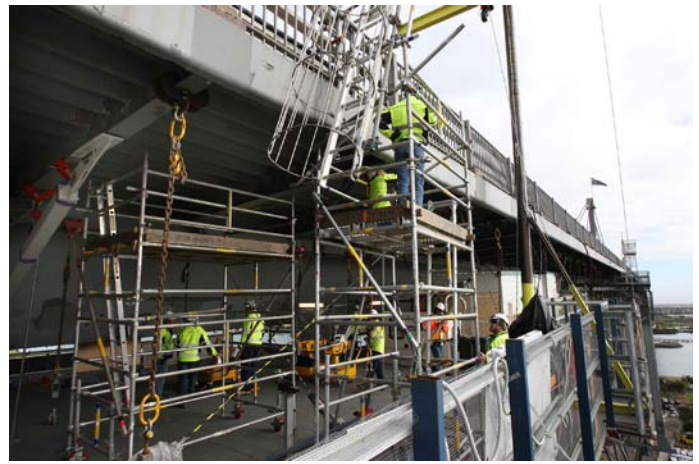
phistication with the design detailing. It was a requirement of the design that the detailing of fabricated elements were small and light enough that they could be lifted into the bridge through the manholes and transported along the inside of the bridge by hand.

It was a requirement of the design that the fabricated elements were small and light enough that they could be lifted into the bridge through the manholes and transported along the inside of the bridge by hand.

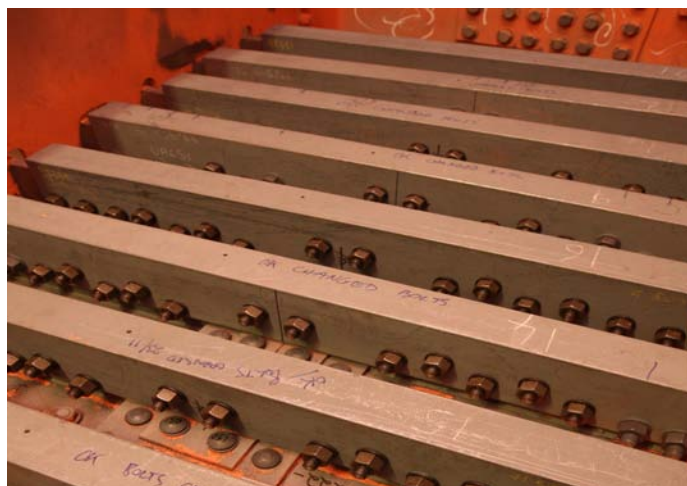
The design and the detailing of components was standardised where possible in order to capture fabrication efficiencies. The nature of the existing structure was that most installation locations were unique so the standard large components were used and they were locally shimmed at the connections to ensure an accurate fit. Throughout the construction period, there was a substantial design team on site as part of the project team. The design team on site was able to address issues that arose on site and speedily provide guidance on what was required to ensure the design intent was met.
