INERT CATCHMENT

TECHNICAL BULLETIN CTB-25

Rev 0, June 2008

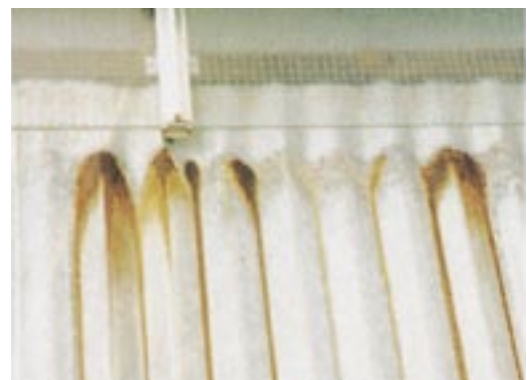
- Water flowing from a glass roof on to galvanized steel roofing (see photo below)

BlueScope Steel recommends the use of COLORBOND® steel, ZINCALUME® steel, COLORBOND® Ultra steel or COLORBOND® Stainless steel in gutter and downpipe applications rather than galvanized steel.

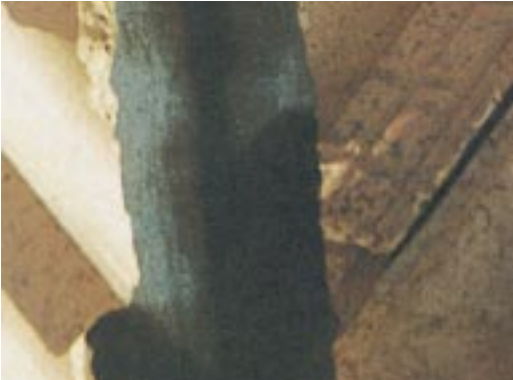
- Water flowing from a terracotta roof into galvanized steel gutter (see photo below)

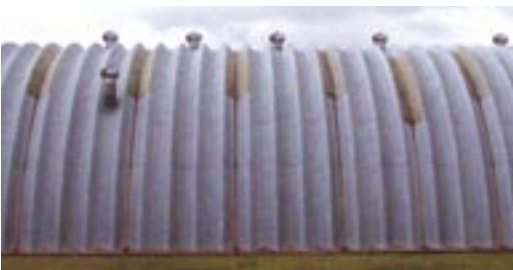
- Fibreglass skylights in conjunction with galvanized steel sheeting (see photo below)

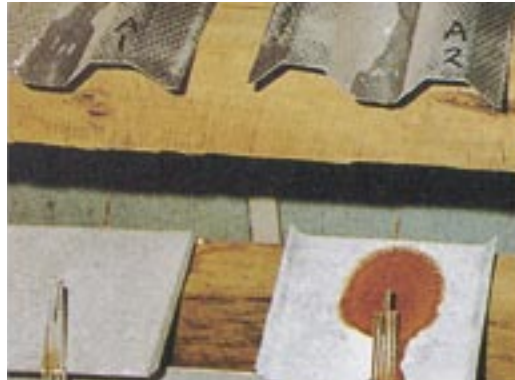
The photographs presented in Tests 1-4 were taken after two years' testing and show that corrosion occurred on a zinc-coated sample below four different roofing material types, including a zinc-coated roof. However, there was negligible corrosion when water flowed from the same four roof types, including the zinc-coated roof, on to ZINCALUME® steel. The test on the ZINCALUME® steel sample was abandoned when no rusting was evident even after it had been exposed without failure for more than 17 times the period it took for rust to form on the zinc-coated sample.

Test 1: Aluminium to ZINCALUME® steel gutter (*left*); aluminium to zinc-coated (galvanised) gutter (*right*).

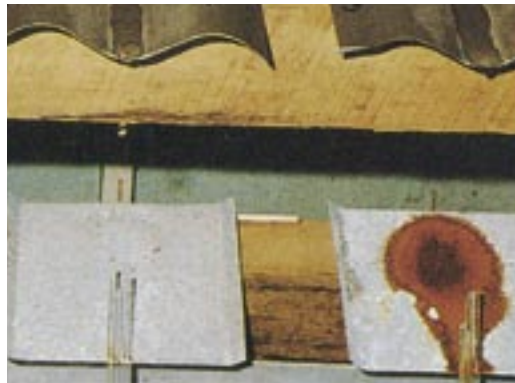
Test 2: COLORBOND® steel to ZINCALUME® steel gutter (*left*); COLORBOND® steel to zinc-coated steel gutter (*right*).

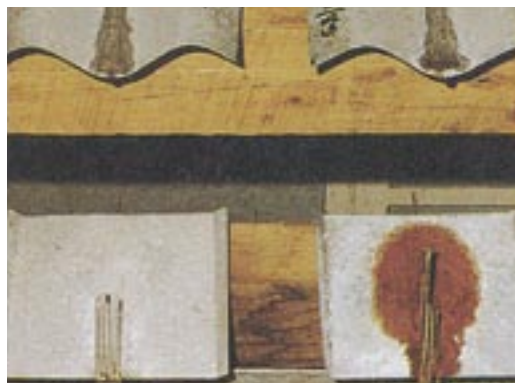
Test 3: ZINCALUME® steel to ZINCALUME® steel gutter (*left*); ZINCALUME® steel to zinc-coated steel gutter (*right*).

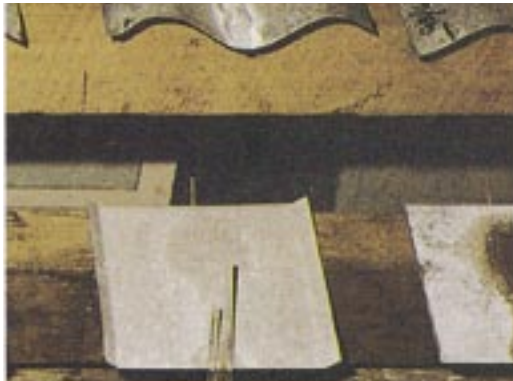
Test 4: Zinc-coated steel to ZINCALUME® steel gutter (*left*); Zinc-coated steel to zinc-coated steel gutter (*right*).

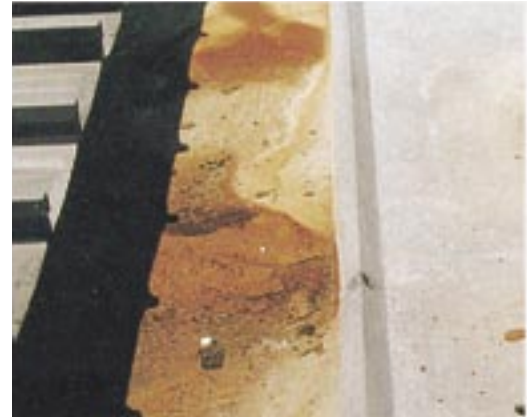
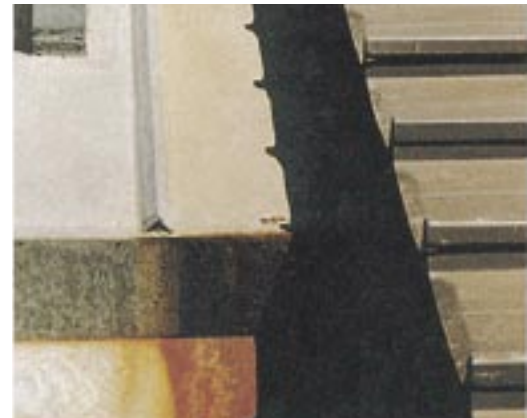
Early gutter failure occurred in all the box gutters and downpipes within 18 months because of the “inert catchment” phenomenon, caused by pure rainwater dripping or flowing into the gutters and sumps. Also noted were localised areas of severe corrosion, with complete loss of protective coating. These areas were caused by ponding where water, such as run-off from the air conditioning plants, had been retained for long periods.

Pictures: Severe corrosion caused by ponding and the use of zinc-coated gutters in combination with roofing of both ZINCALUME® zinc/aluminium alloy-coated steel and COLORBOND® prepainted steel.

The specification of COLORBOND® steel, ZINCALUME® steel, COLORBOND® Ultra steel or COLORBOND® Stainless steel gutters and downpipes, installed to avoid ponding by allowing water to flow easily through and away, can prevent the type of corrosion observed in this case study.
