# 18. GALVANIZED COATING DEFECTS

## INTRODUCTION

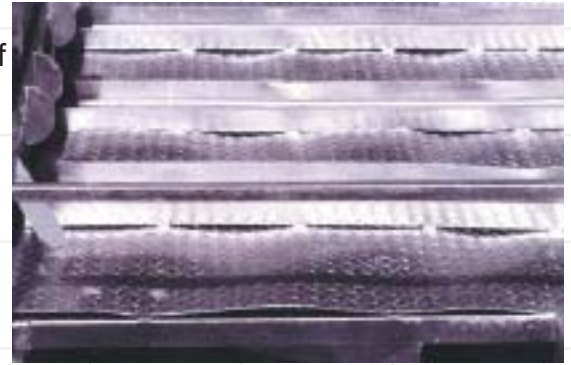
*Distortion of thin checker plate welded to heavier supporting members can be reduced by fixing the checker plate after galvanizing*

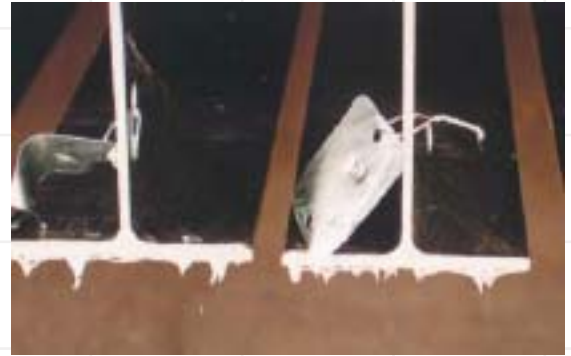
*Drainage spikes will always occur where edges are parallel to the molten zinc surface. These are removed by grinding or filing during the inspection process.*

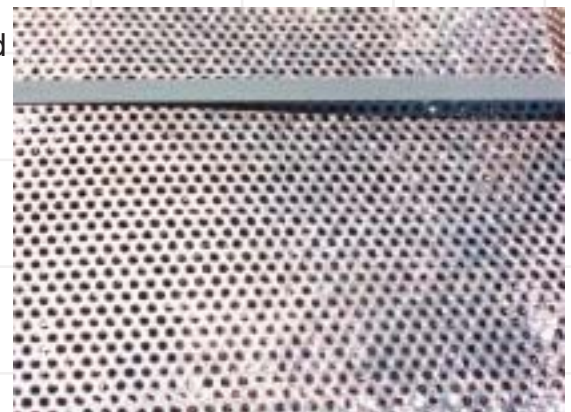
*Blinding of small holes (6mm or under) will occur because of the surface tension of the molten zinc. This can be minimised by detailed attention to the item as it emerges from the molten zinc.*

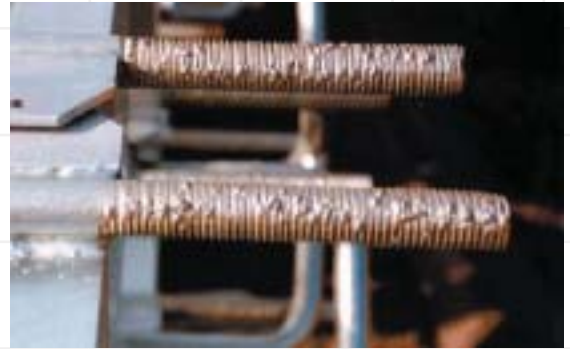
*Threaded items will usually require post-galvanizing treatment to clean the threads of zinc. This can be done by reheating the threads to galvanizing temperature (450oC), then removing the excess zinc by wire brushing.*

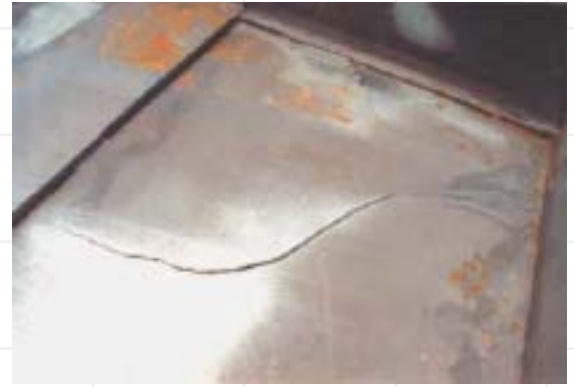
*The fracture of Bisalloy wear plate is a result of Hydrogen embrittlement arising from the pickling process. High strength (over 800 MPa) steel is susceptible to this type of embrittlement.*

Hydrogen atoms from the acid pickling process penetrate the grain boundaries of these high strength steels and can cause brittle fractures under certain conditions. Many high strength steels can be galvanized and standard pre- or post-galvanizing treatments are available to eliminate the risk of hydrogen embrittlement.

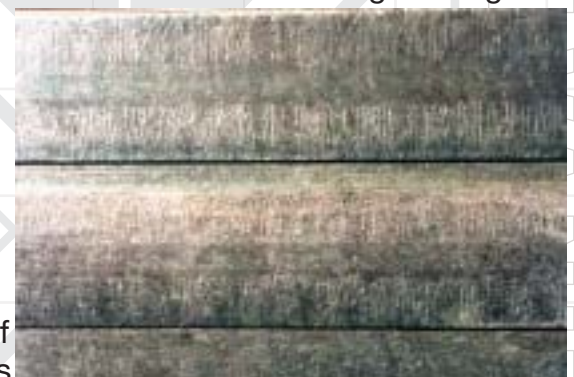
*These lateral striations are a result of surface stresses in the steel section cause by the rolling process reacting at a higher rate with the molten zinc than the surrounding steel.*

The manufacturing operations performed on some steel sections can also show up in the form of visual defects, the most common of these being striations. These are narrow (typically about 1-2 mm wide) longitudinal raised lines in the coating usually running the full length of the section.

The most common cause of striations is stress lines on the surface of the steel caused by cold working of the section. Heavy gauge rod will sometimes show a spiral striation pattern arising from the rod or wire being passed through a roller/straightener prior to final manufacture.

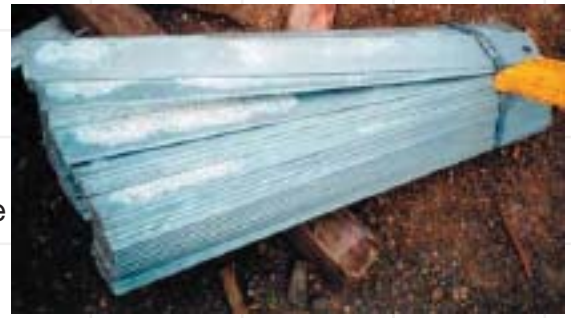
*The 'white rust' on these galvanized flat bar sections has been caused by their being wet in the bundle. Galvanized coatings require good ventilation when newly applied to allow the passive oxide films to develop.*

The main white rusting problems arise where galvanized work is stacked or packed in tightly nested bundles, where water can be trapped and air circulation is poor.

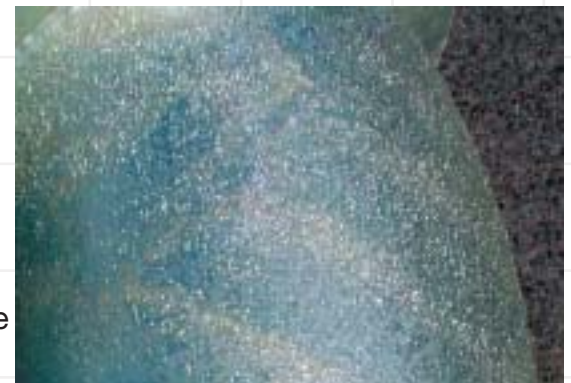
*Dross pimples on this pipe spool arise from dross crystals being stirred up from the bottom of the galvanizing bath by long or deep items. Appearance is unsightly but durability is unaffected.*

- If the item comes in contact with the dross layer in the bottom of the bath, the dross can get caught in or on the work and form a rough, lumpy deposit.
- If areas of the item are inaccessible for skimming, ash may stick to the surface of the galvanizing as it is withdrawn from the bath.
- If the rate of withdrawal varies or stops during the extraction of the galvanized item from the bath, tide marks (oxide lines) may appear on the surface of the galvanizing causing variations in the shiny appearance of the coating.
- With smooth-surfaced work such as tanks or large diameter pipes, dross crystals floating in the bath may be caught up on the galvanized coating. These 'dross pimples' give the coating a gritty appearance.

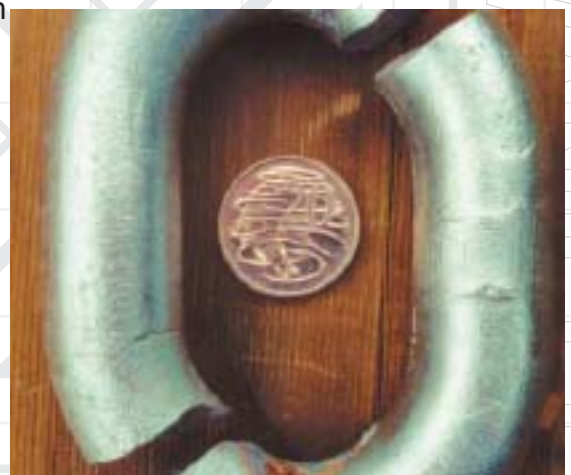
*Hydrogen embrittlement failure of Herculloy chain is caused by exposing this 1200 MPa steel to pickling acid. These types of steels should not be galvanized.*

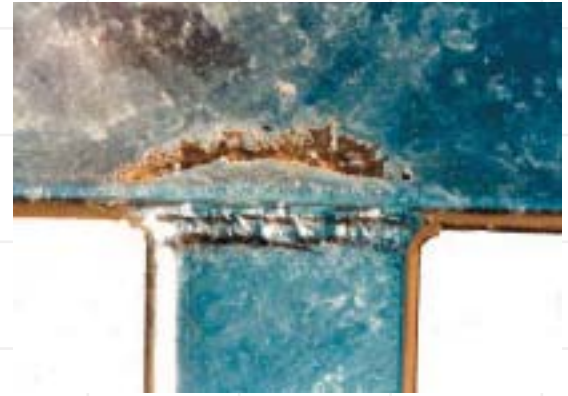
*This miss in the galvanized coating is caused by surface contamination by residual oxides not removed in the pickling process.*

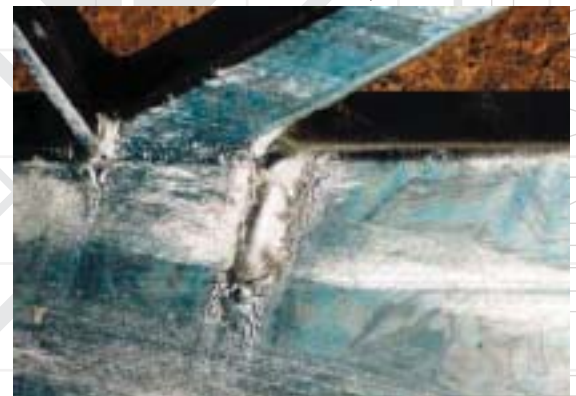
*Zinc run caused by zinc freezing while draining from flat RHS surface. Durability is enhanced but thick runs may interfere with connecting surfaces*

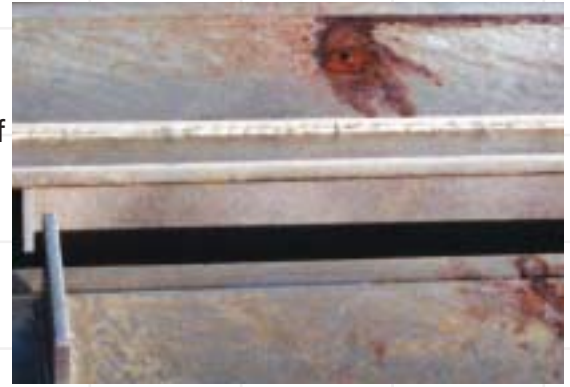
*Flux staining has occurred on unsealed vent holes in overlaps on this fabrication. The stains are caused by iron salts, that have penetrated the overlap during pre-treatment, re-hydrating with atmospheric moisture.*

Another defect arising from unsealed overlapping surfaces is the 'bleeding' which occurs out of the overlap after galvanizing.

This is commonly referred to as 'acid staining'. Hydrochloric acid vaporises at below 200 degrees C so there is never any acid residues left in or on the item after galvanizing.

The staining that occurs is caused by flux residues that have been desiccated by the heat of the galvanizing process, re-hydrating from contact with atmospheric moisture.

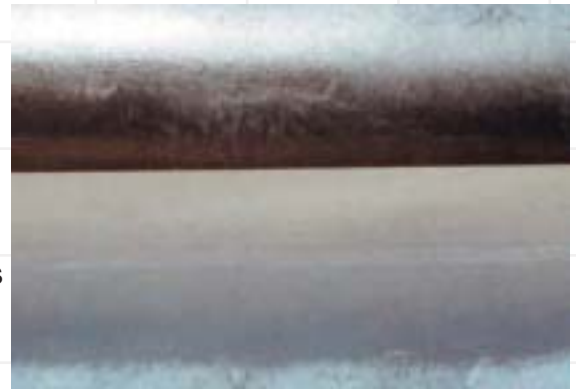
*The gray coating on these pipes is a result of high silicon content of the steel, making it more reactive and converting all the coating to zinc-iron alloy. These gray coatings are typically thicker than shiny galvanized coatings on similar sections.*

For example, a dull or mottled galvanized coating may be 2X or 3X as thick as a standard shiny coating that complies with the relevant standard. The thicker gray coatings will thus have a coating life 2X or 3X as long as the standard coating.

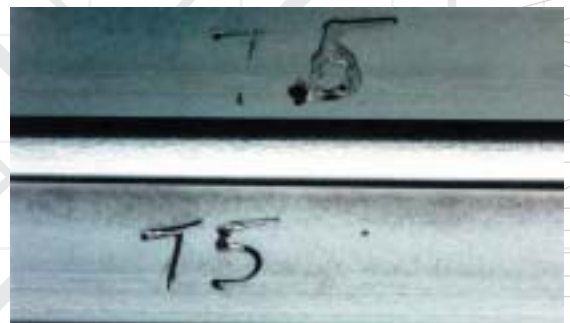
*This miss in the galvanized coating is caused by surface contamination by an incorrect type of marking paint that is resistant to removal by pre-treatment chemicals.*

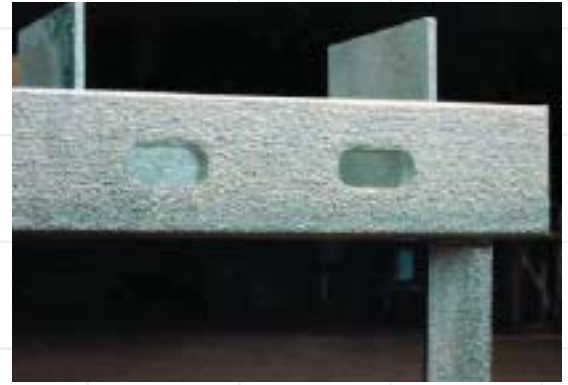
*The textured surface on this steel angle results from the rough as-rolled surface of the base steel, usually cause by excessive mill-scale on the steel section in the hot rolling process.*

The surface condition of the steel will be reflected in the galvanized coating in two ways. Rougher surfaces have a higher surface area per unit of surface and thus generate thicker galvanized coatings. Hot rolled sections typically produce hot dip galvanized coatings 30-50% thicker than smooth, cold rolled surfaces.

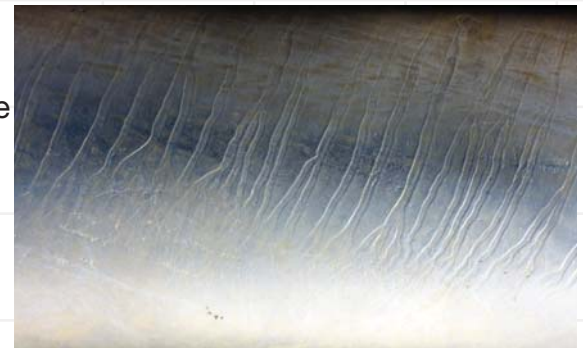
*Fishbone striations on large diameter pipes arise from surface stresses in the steel causing different zinc-steel reaction rates on the pipe surface.*

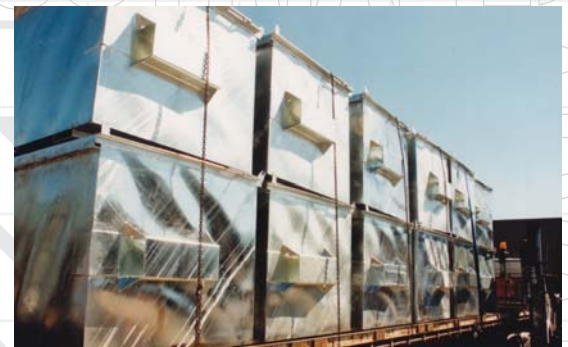
*Thin, flat sheet will always buckle in the galvanizing process. Corrugating or ribbing of these type of sections will significantly reduce the likelihood of distortion during galvanizing.*

Thin plate sections are most prone to distortion, and this is caused by the rapid differential heating and cooling of the sections, and its relative weakness as a thin section.

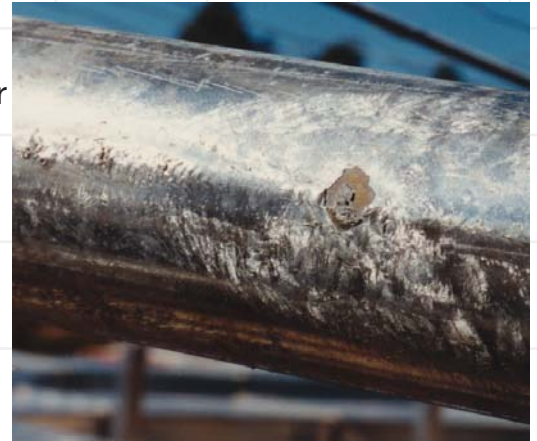
*Where jigs are used to support large items in the galvanizing processes, touch marks will occur where the galvanized coating adheres to the jig at the point of contact.*

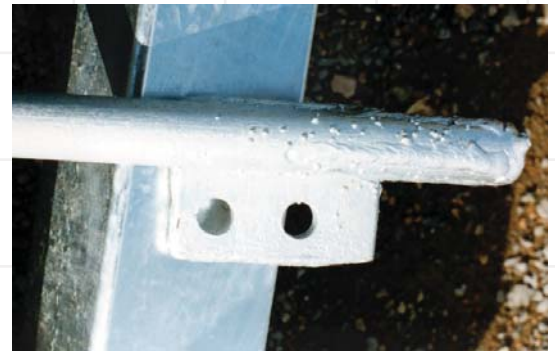
*Weld splatter left on the steel will be galvanized along with the work, resulting in a rough and pimply appearance.*

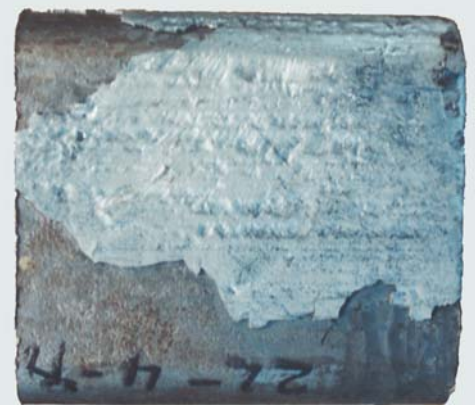
*This small RHS section has severe galvanized coating delamination arising from very high phosphorous levels in the steel, creating a thick, fragile coating almost 1000 microns in thickness.*

High phosphorous levels (not normally found in structural steels) can give rise to dark gray or browning coatings that are prone to delamination from the steel's surface.
